**CWA COMPLIANCE EVALUATION INSPECTION REPORT
U.S. ENVIRONMENTAL PROTECTION AGENCY, REGION 5**

Facility: Bischer Farms
6121 Purdy Road
Ruth, Michigan 48470

NPDES Permit Number: MI0057669

Date of Inspection: 08/28/08

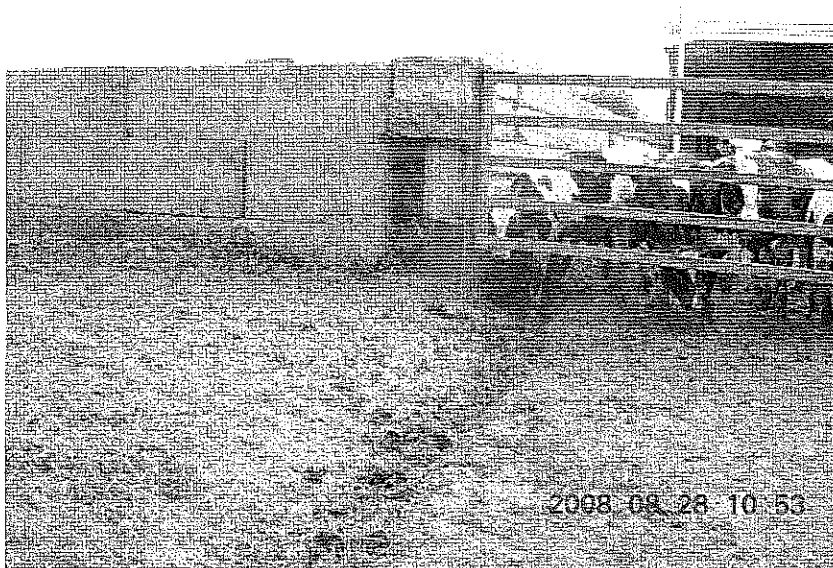
Photo 50 (DSCN 4050)

Description: Runoff from paved pad underlying east side of East Sector, located just south of concrete compost structure in photo 40, above. Liquid runs into trough connecting Catch Basin 7 to Catch Basin No. 1, from which it is pumped to the holding pond.

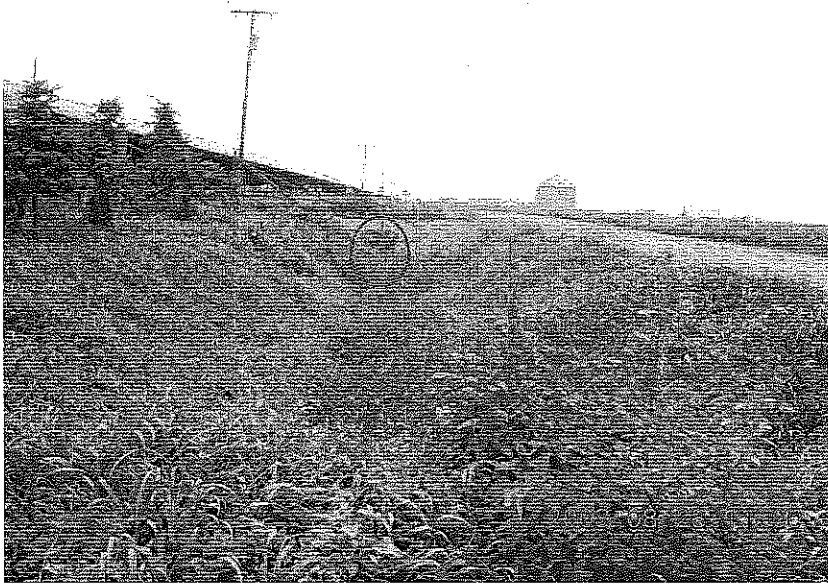
Photo 51 (DSCN 4051)

Description: Roadside ditch viewed from Driveway No. 2. Purdy Road, right. Black pipe in center background (indicated by pink circle) is the emergency valve, which can be manually closed to prevent flow through culvert underneath Driveway No. 3, background.

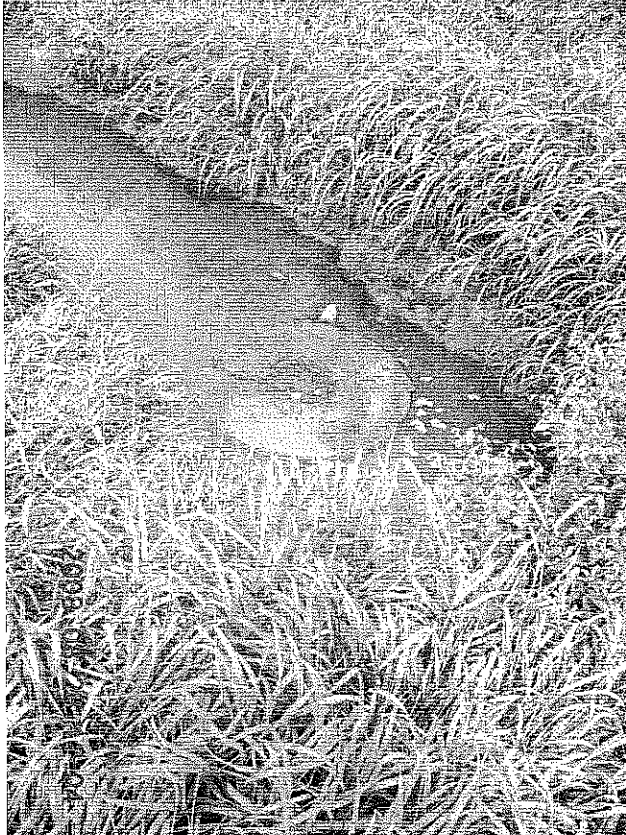
Photo 53 (DSCN 4053)

Description: Roadside ditch viewed from Driveway No. 3, just north of emergency valve. Mr. Geiger said that standing water is due to low ditch bottom.

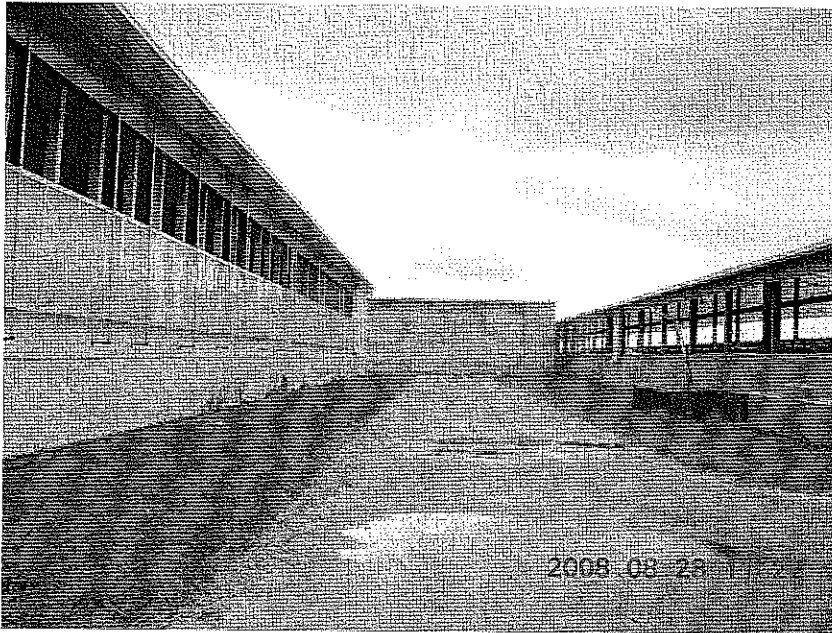
Photo 54 (DSCN 4058)

Description: Area between north calf barn (left) and south calf barn (right) in West Sector. Gutters on south side of north barn and north side of south barn direct storm water to the ground.
